AIRGAS MERCHANT GASES

Dublin, GA

Improper Adsorber Vessel Filling August 13th, 2018

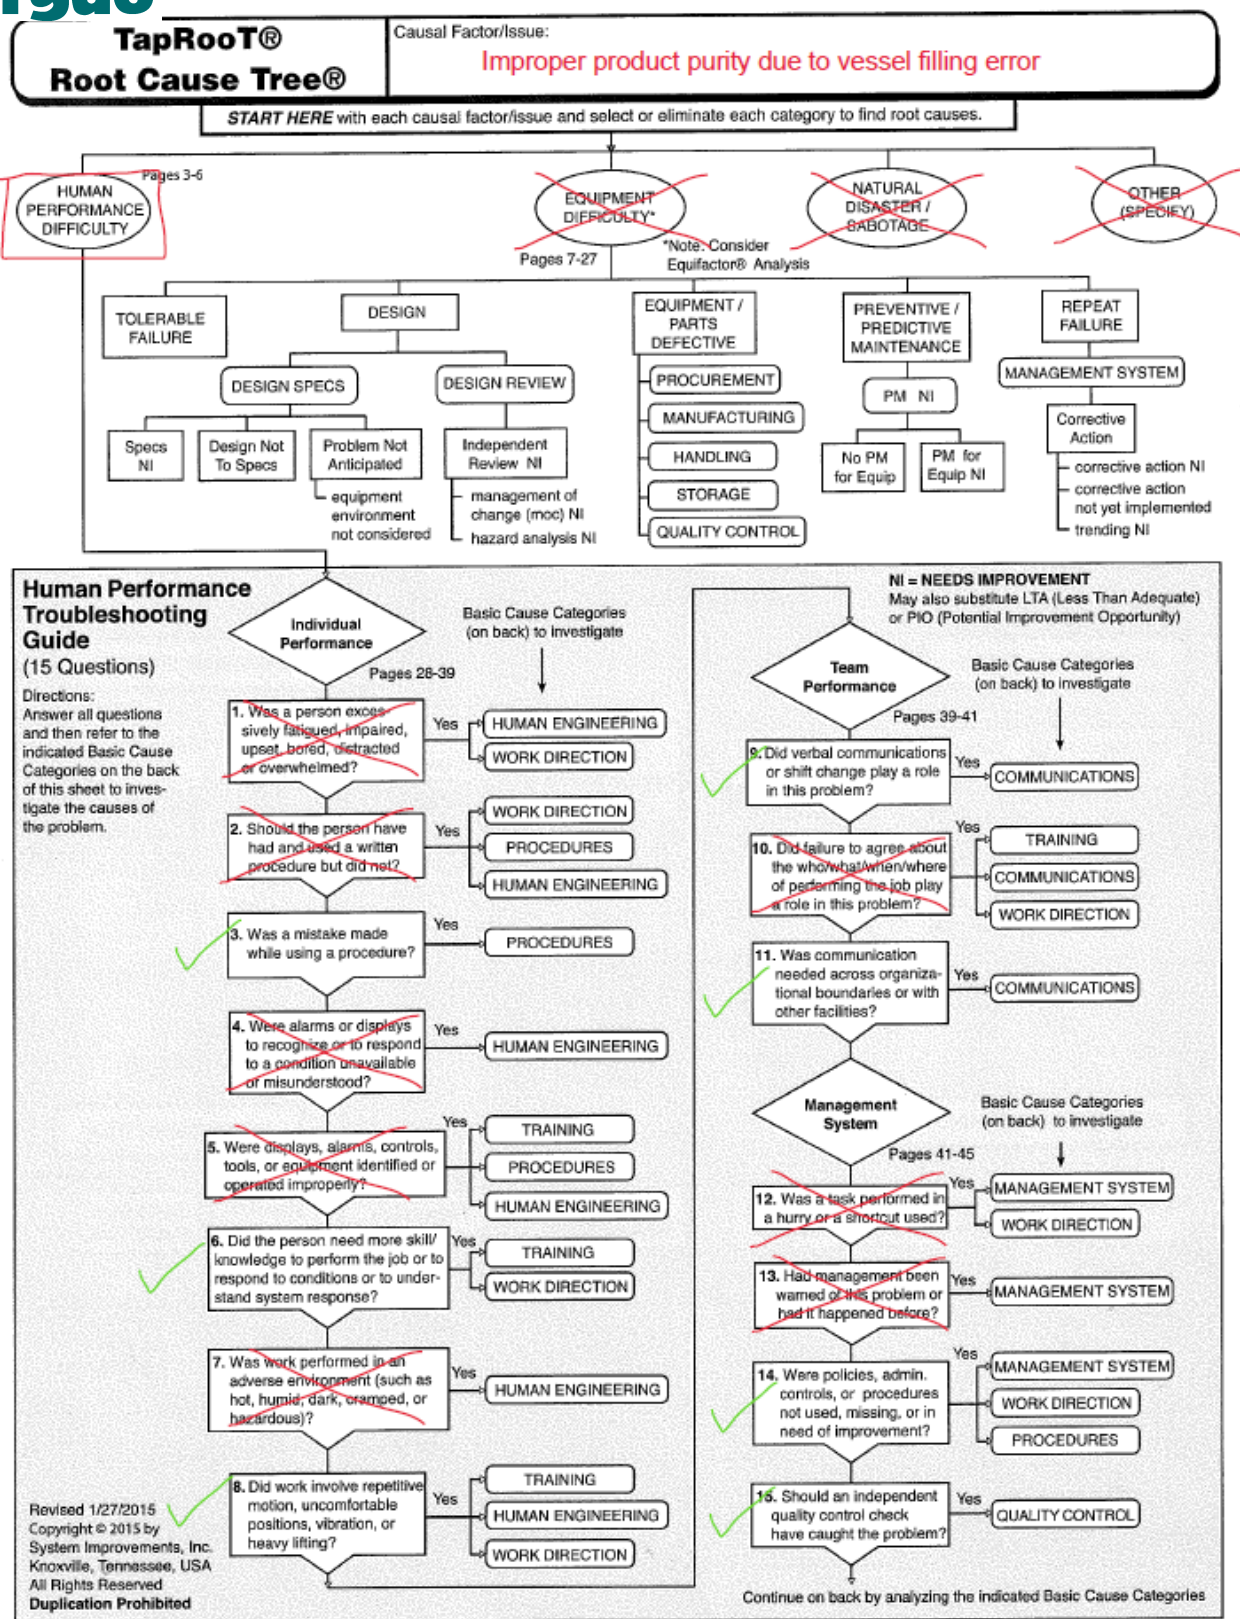
Drilling down into each cause category yielded the following root causes:

- Procedures followed incorrectly, check off misused

This is the most obvious root cause as its been previously detailed that the AL spec. on adsorber vessel filling was already given to RPS to follow and an error was made when filling the alumina layer.

After the completion of work, RPS needed to visually inspect the level in the adsorber before filling the top layer with mol sieve. The confined space team part of RPS did not appropriately validate the height of alumina before proceeding. This was confirmed when the investigation team found that alumina levels in all three beds were overfilled by four inches.

The root cause investigation yielded that procedures were not adequately followed overall by the RPS team and it resulted in the bottom alumina layer being overfilled past what was required. The root cause team recommends the whole RPS team sitting down with Airgas personnel and reviewing the job and AL spec. prior to beginning work. RPS should explicitly acknowledge the proper filling heights so that there is no ambiguity between what has been communicated and what is carried out. Following completion of any bottom layer alumina filling. There should be a visual check presented to Airgas for proper height verification before proceeding onwards.

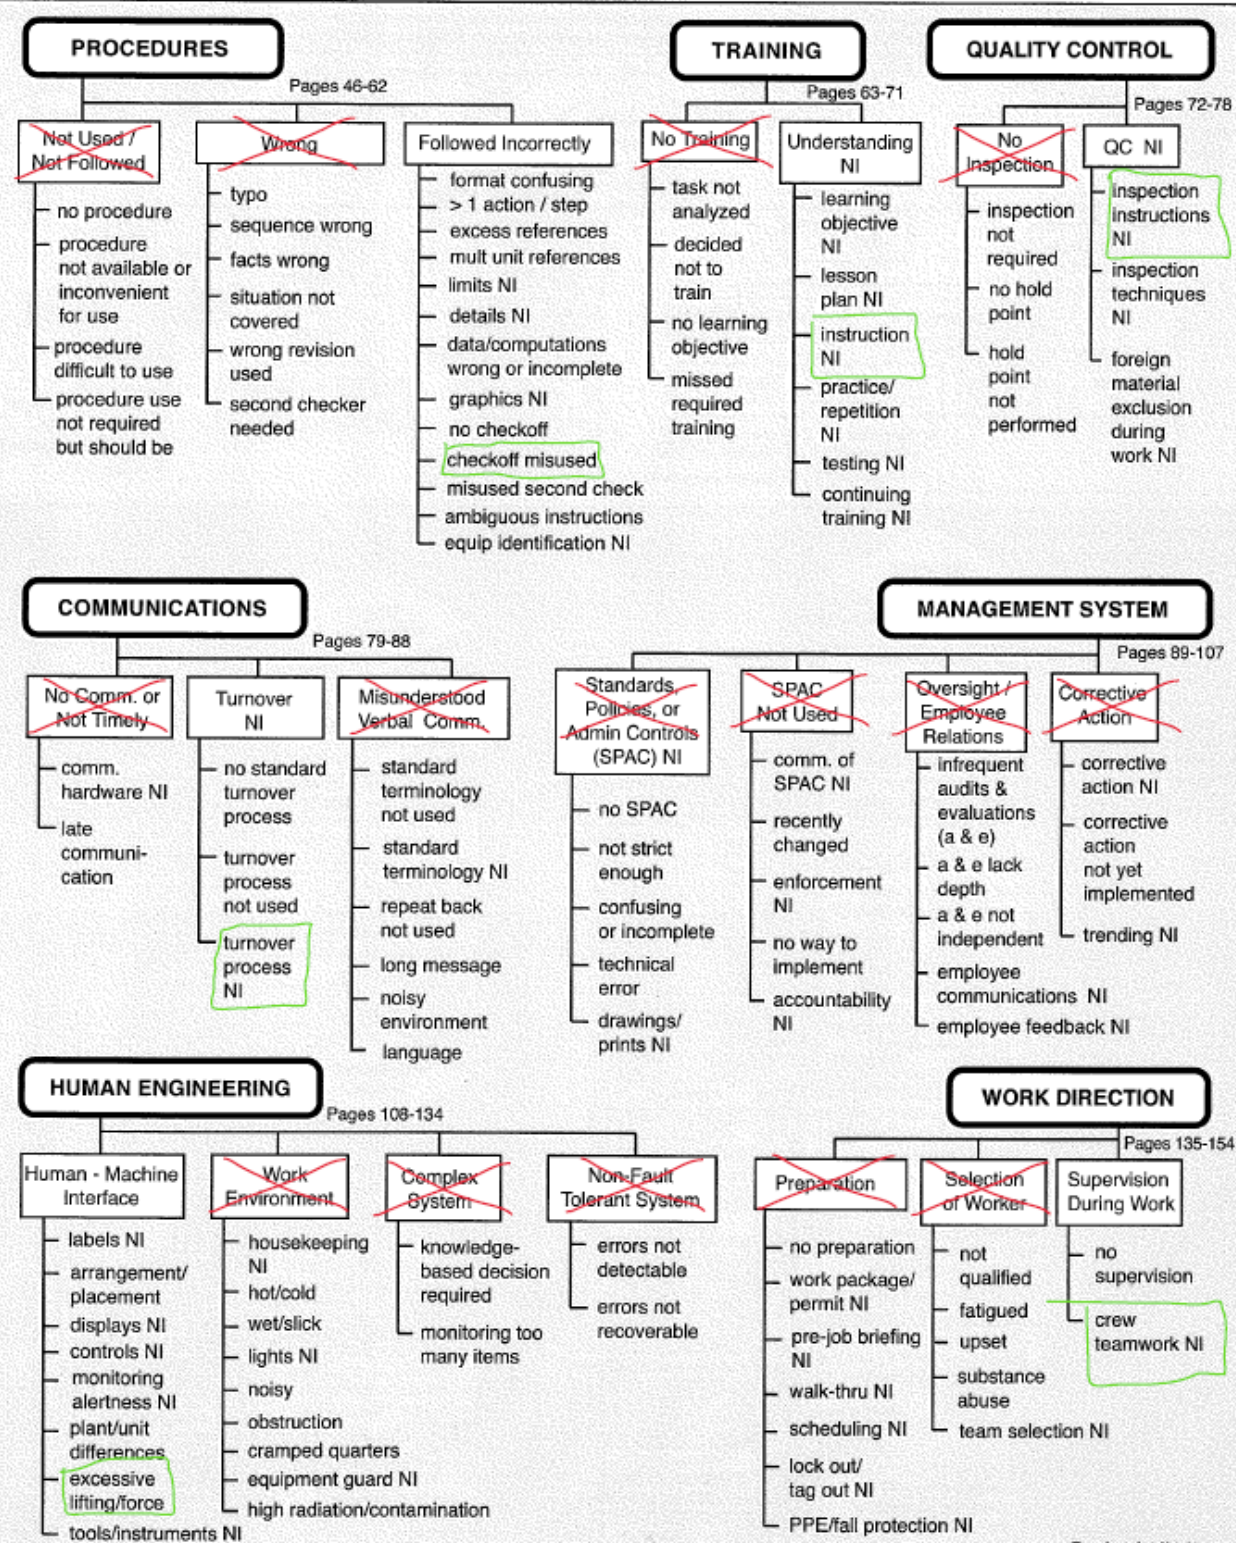
TapRoot® Root Cause Tree® Basic Cause Categories

Similar to the training root cause, the confined space team that did the final measurement of the alumina level should have been aware of the appropriate target height and caught the overfilling immediately.
